Testing Concrete Slabs according to S115 Standard

Author(s): Nour Elsagan
Report No.: A1-016259.1
Report Date: 28 November 2019
Contract No.: A1-016259
Agreement Date: 13 August 2019

Université Laval was interested to get information on the behaviour of a concrete slab with two openings during fire. A fire test was conducted in the intermediate furnace at the National Research Council (NRC) following the CAN/ULC-S115 standard. The results showed that, filling one of the openings with rock (mineral) fiber successfully limited the heat transfer from the exposed surface to the unexposed surface and kept the temperature of the unexposed surface below the temperature limits stated in the standard.

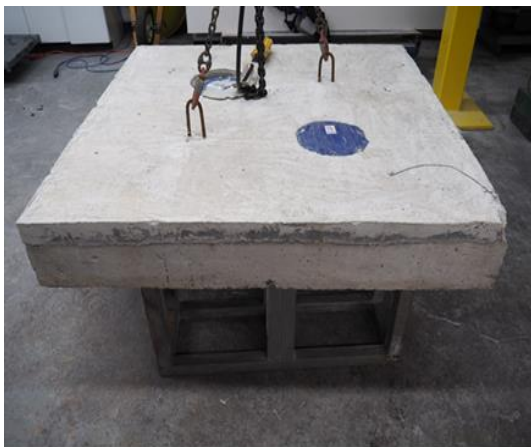
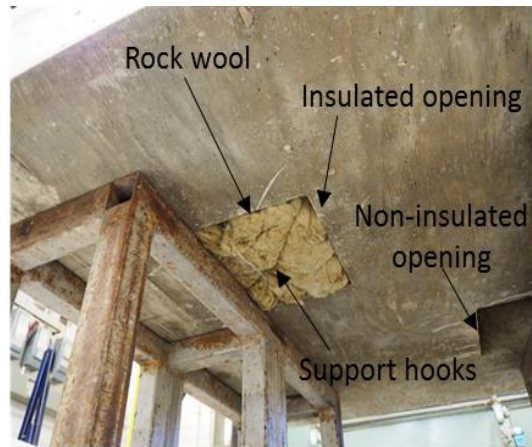
Figures 3(a) and (b) show respectively photos of the slab from unexposed and exposed sides when delivered to NRC. Some of the rock wool and the supporting hooks can be seen in figure 3(b).

Figure 3. Photos of the slab when delivered to NRC

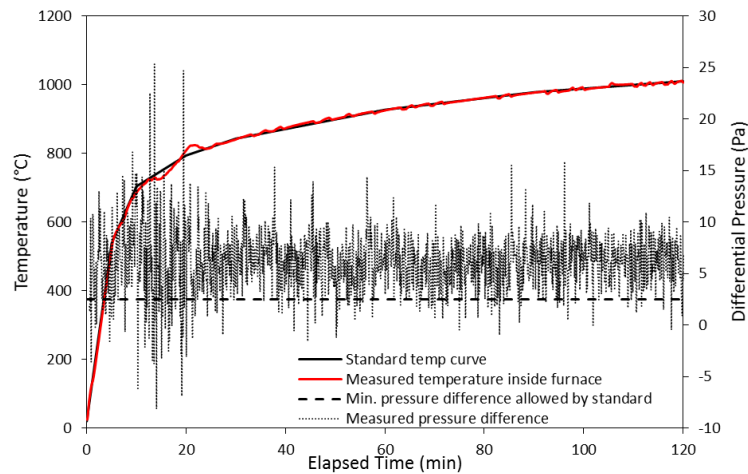
Figure 5. Temperature Curve as per CAN/ULC-S115 (black line) vs average furnace temperature (red line). Measured ΔP inside the furnace (dotted line) vs min. required ΔP

The slab was tested in the intermediate-scale furnace at NRC. One side of the slab was exposed to the fire prescribed by CAN/ULC-S115. The NRC intermediate-scale furnace has a fire chamber where specimens up to a maximum size of 135 cm (53 in) by 198 cm (78 in) can be tested. The temperatures in the intermediate-scale furnace were measured using four Type K chromel-alumel thermocouples. The average temperatures measured by the furnace thermocouples was used to automatically control the furnace temperature. The standard temperature curve and the average temperature inside the furnace are presented in Figure 5. A pressure probe was placed at 43 cm below the exposed surface to measure the pressure gauge inside the furnace.

During the test, a minimum pressure difference (ΔP) of 2.5 Pa was maintained between the exposed and unexposed surface as required by the standard. The measured ΔP during the test time is presented in figure 5. The readings of the thermocouples were recorded at an interval of 5 s and the unexposed surface was monitored using a camera installed close to the top side of the slab.

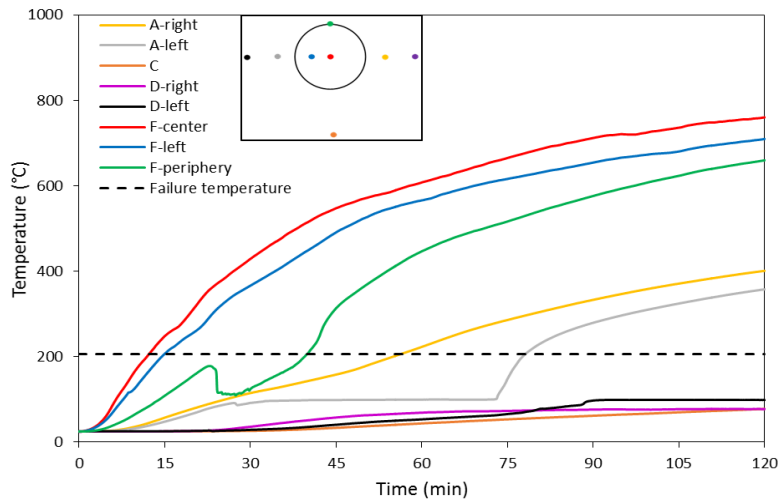
Figure 6. Temperatures on and around the non-insulated opening. The inset represents a colored schematic of the locations of thermocouples. Refer to figure 4(a) for the exact locations

Figures 6 to 8 show the temperatures measured by the thermocouples placed on the unexposed surface of the slab. The initial temperature of the unexposed surface was 25°C, thus the failure temperature according to CAN/ULC-S115 should be 206°C. This temperature is presented in figures 6 to 8 as the black dashed line. It can be clearly seen in Figure 6 that five temperature measurements on the surface of the non-insulated (empty) opening exceeded the failure temperature. The three highest temperatures were: the temperature at the center of the opening cover (reached 207°C at 12.5 min), followed by the temperature at 2.5 cm from the periphery (exceeded the failure temperature at 15 min), then the temperature at the opening periphery (exceeded the failure temperature at 40 min). It is worth noting that, the cover of the non-insulated opening started to lift up at 26 min and the surface below started to glow at 109 min. Figure 9 shows a photo of the lifted-up cap near the end of the test and the glowing surface below it.

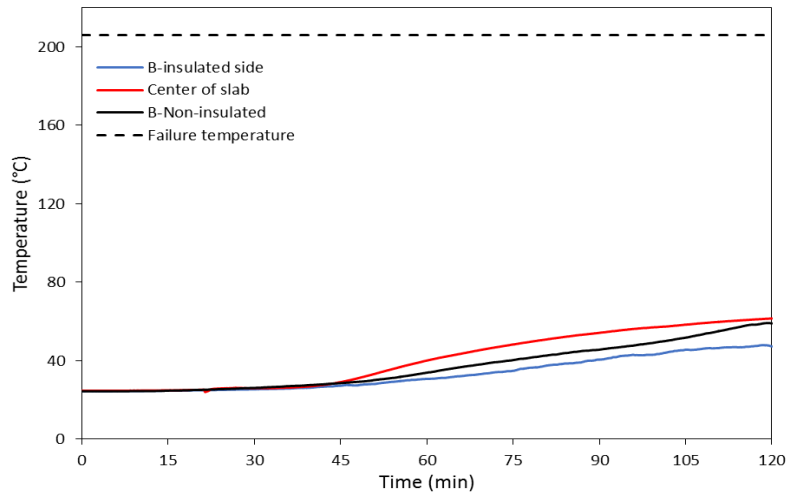
Figure 8. Temperatures at center of the slab and B-locations in figure 4(a)

On the other hand, figure 7 shows that the temperatures on the surface of the insulated opening (filled with rock fiber) which didn't reach the failure temperature. The maximum temperature during the test (2 hrs) was 94.4°C at the center of the opening cover. Thus, the rock fiber successfully limited the heat transfer from the exposed surface to the unexposed surface and prevented the rise of the temperature of the unexposed surface above the failure temperature. Figure 8 shows the temperatures at the center of the slab and on the periphery (B-locations in figure 4(a)). The temperatures at these locations didn't reach the failure temperature as seen in the figure. The maximum temperature was 61.5°C at the center of the slab.

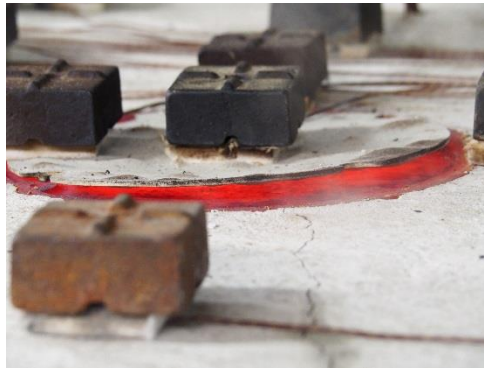
Figure 9. A photo showing the lift-up of the cap of the non-insulated opening and the glowing surface below it.

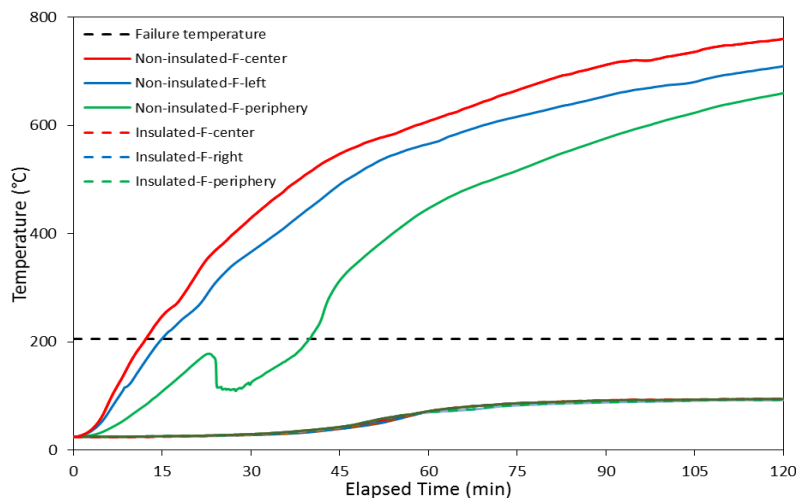
Figure 10. Comparison of the maximum temperatures on the insulated and non-insulated openings.

Figure 10 compares the maximum temperatures on the unexposed surface of the insulated and non-insulated openings. Three temperatures are shown for each of the openings: at center of the opening cover, 2.5 cm from the periphery and periphery. The figure clearly shows the effectiveness of the rock fiber in limiting the heat transfer across the slab and avoiding the rise of the surface temperature above the failure temperature.

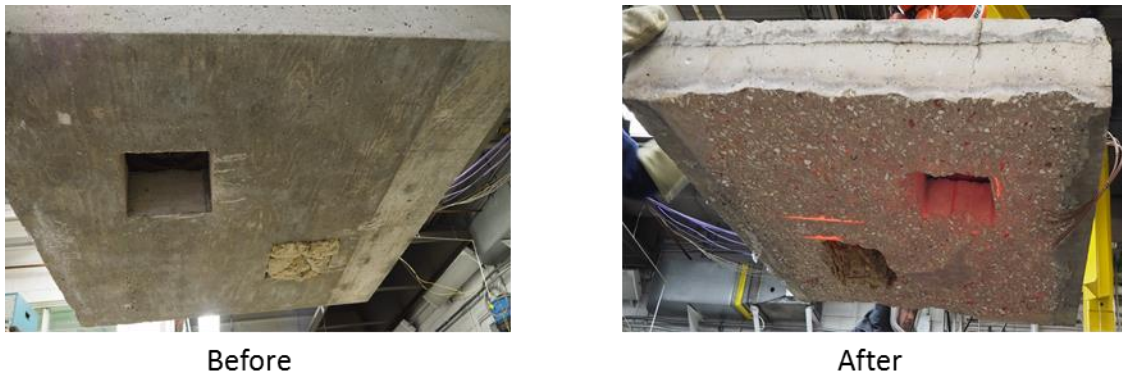
Figure 11 shows the exposed surface of the slab before and after the test. A lot of damage can be seen on the surface after the test. Moreover, some cracks can be seen near the insulated opening. Even though, the temperatures on the unexposed surface above the insulated opening were kept below the failure temperature as a result of using the rock fiber.

Although some of the rock fibre can be seen out of the insulated opening, none of it fell down in the furnace.

Figure 11. Photos of the exposed surface of the slab before and after the test.
